WIPP Underground Fire Accident Investigation Summary February 5, 2014

Ted Wyka
Chairman, Accident Investigation Board
March 2014

The Accident

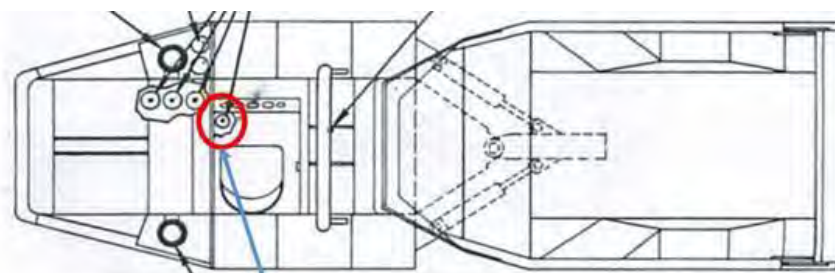
(a) Plan View

- The Board has been unable to perform detailed physical forensics on the vehicle underground due to the February 14th radiological event.
- The Board reviewed photographs taken with forensic experts including a New Mexico Fire Investigator from the State Fire Investigation Bureau and the Eddy County New Mexico Fire Marshall.
